# **ATX SECOND STAGE REGULATOR**

## **MAINTENANCE MANUAL FOR AUTHORISED TECHNICIANS**

ATX Second Stage Maintenance Manual  
(AP5826 Issue 5)

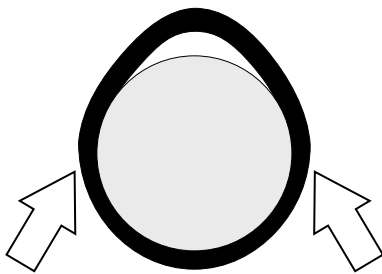
Press upwards on sides of 'O' Ring to create a protrusion.

Grab 'O' Ring or insert 'O' Ring tool at protrusion.

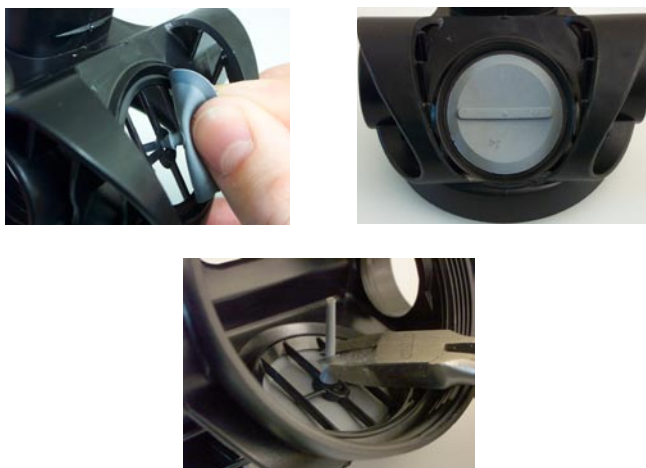
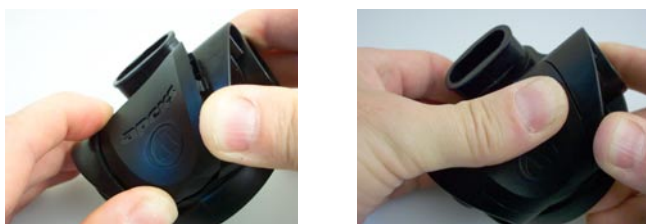
### Fitting Exhaust Valve and Exhaust Valve Cover

**! WARNING:** Flooding may occur if the tail of the valve is not fully pulled through. Check that barb has engaged on inside of Case.
